Executive Summary

Event Description

Turkey's Seismic Profile

Damage Observations

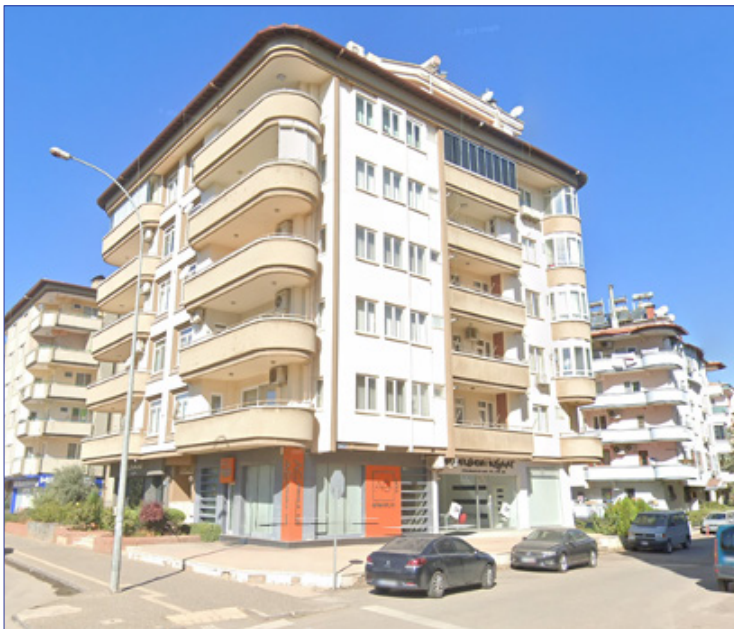
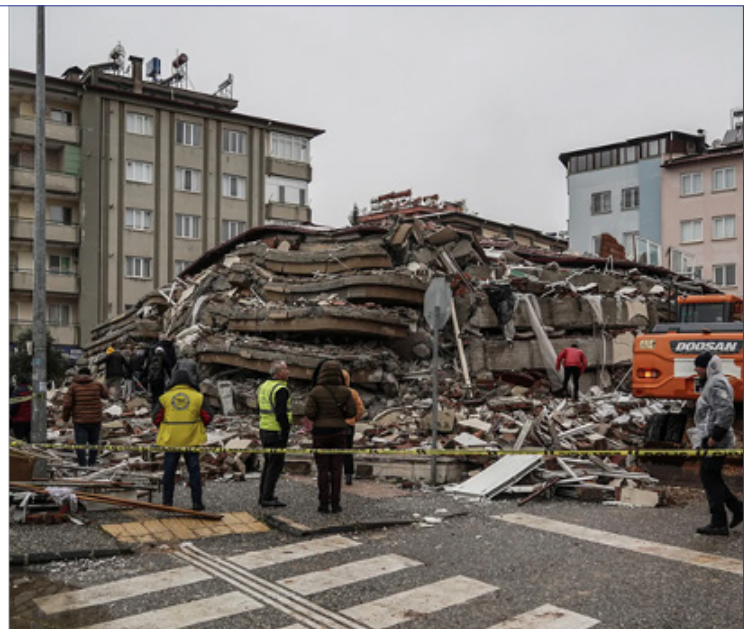
Figure 3 - Residential building in Gaziantep with a “pancake collapse.”¹⁵

Shake damage to structures in Turkey was widespread and devastating. Over 190,000 buildings have collapsed or are in need of demolition, 36,000 are moderately damaged and 350,000 are slightly damaged.⁸ A common observation has been so-called “pancake collapses” where weakness in load-bearing columns triggers a sudden vertical collapse of a building’s floors (Figure 3). This type of failure provides no time for evacuation and can significantly increase the number of casualties. Furthermore, several construction deficiencies have been noted including poor material quality, insufficient concrete reinforcement, and improper column design. Most alarming is that approximately half of households affected by the earthquake lived in building constructed after 2001.⁹

- **Amnesties:** The Turkish government has periodically offered construction amnesties that legally exempted new construction from certain design requirements for a fee.¹⁰
- **Regularization:** Existing buildings not satisfying code requirements are periodically regularized without necessary retrofits. An estimated 294,000 impacted by the earthquake were regularized in 2018.¹¹
- **Illegal Construction:** Illegal addition of floors or removal of columns is commonplace.¹²
- **Poor Inspection:** Required auditing of construction sites is frequently done by inspectors selected and paid for by contractors themselves.¹³
- **Soft-Stories:** Most residential dwellings have a ground floor commercial space with an open floor plan. This decreased lateral resistance relative to the rest of the building creates a “soft-story” that can initiate building collapse.¹⁴
